ERDC/CHL TR-01-26

Impacts of Navigation Channel Maintenance Dredging on the Coastal Processes of Chatham, Massachusetts

Donald K. Stauble

September 2001

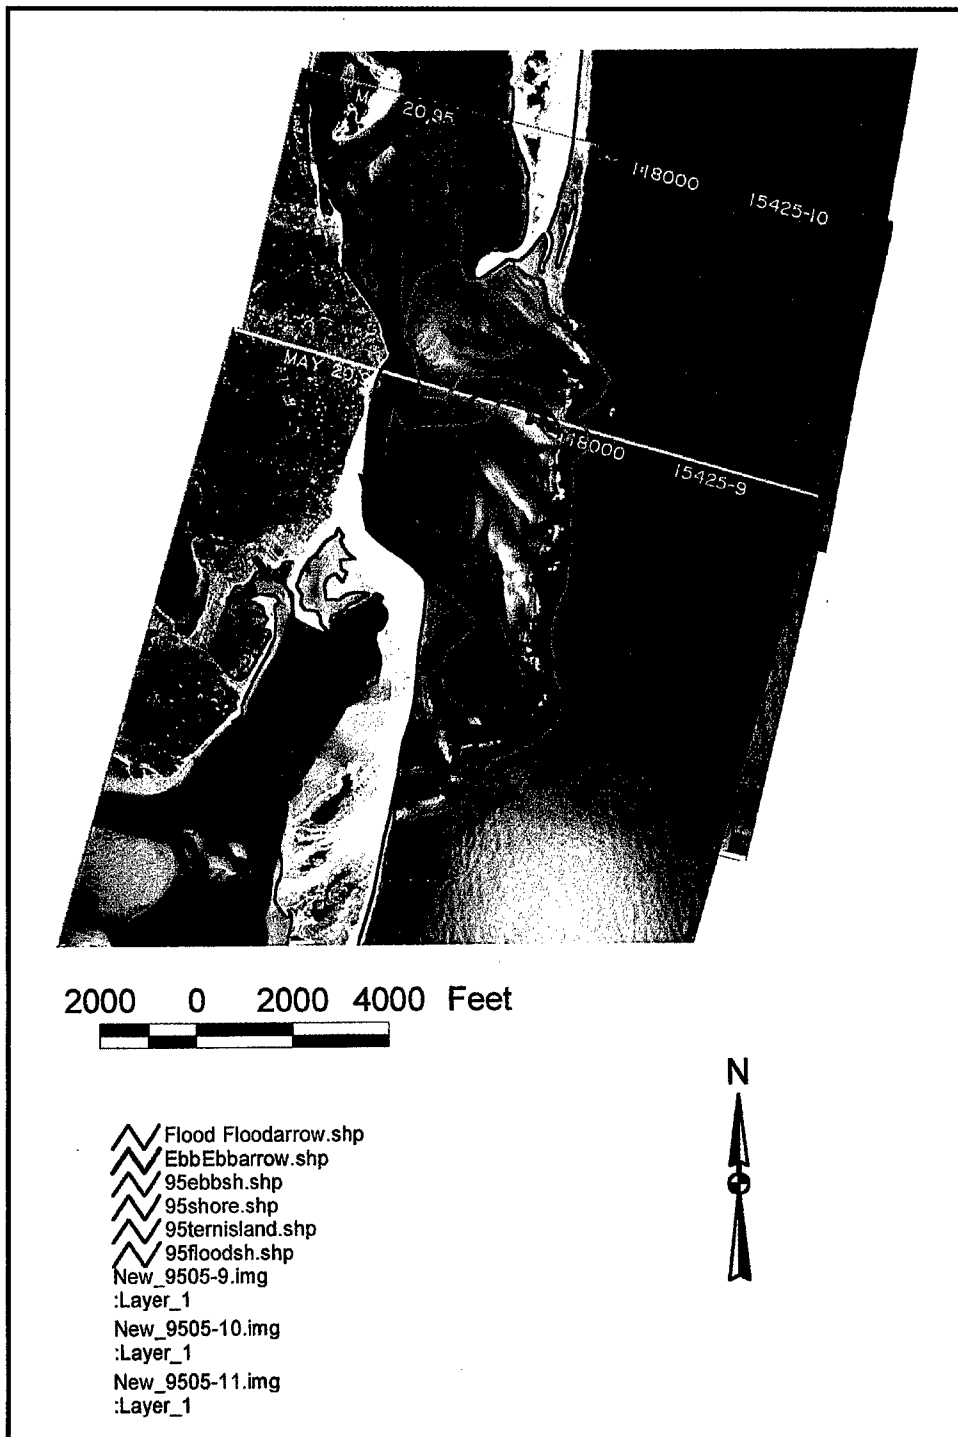
Figure 51. Sediment transport pathways based on morphology from May 1995

With the closure of south Chatham Harbor and the establishment of the second north ebb channel, Chatham Inlet continues to evolve toward a dynamic equilibrium with the prevailing coastal processes. Net changes in the main ebb channel, ebb shoal edge, north spit and South Beach land bridge for the third period from 1995 to 1999 are shown in Figure 52. With the southern main ebb channel extending some 6,000 ft (1,829 m) in length and being forced against the mainland beach by the ever expanding ebb shoal, the flow through this channel is much more restricted than before. Over this last 3-year period, the position and orientation of this channel has remained relatively stable. The newer north

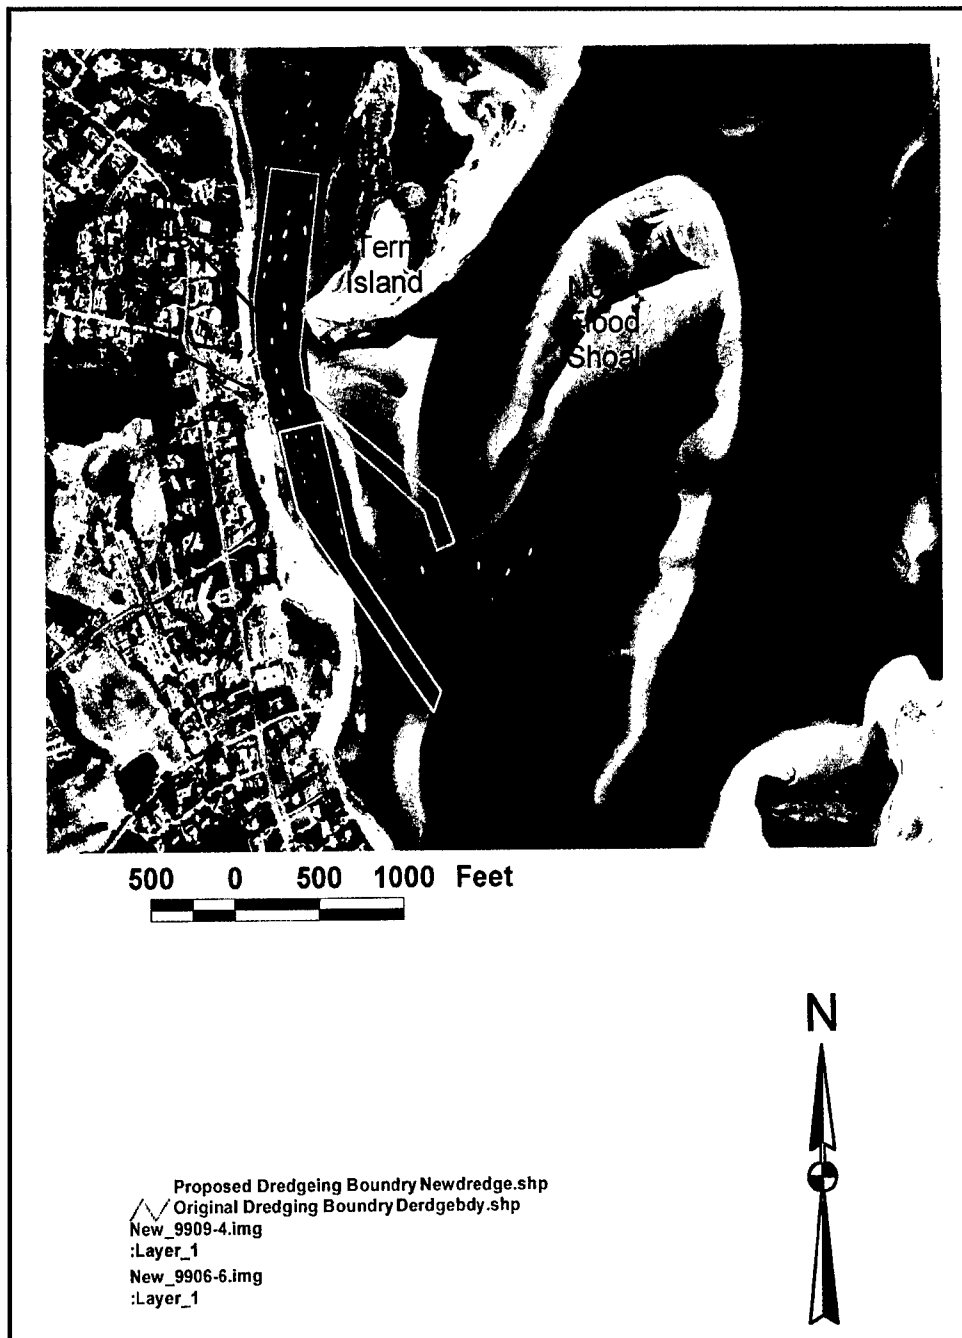
Figure 54. Previous boundaries from 1994/95 dredging and proposed new orientation of dredging boundaries based on current morphodynamics

The maintenance of navigation channels at Aunt Lydia's Cove will continue to be a challenge. It is recommended that in the short-term, dredging of the west ebb spit of the flood shoal be continued in its general location as shown in Figure 54. A re-examination of the orientation will be needed after the west flood channel re-establishes itself and the sand in the detached western part of the flood shoal takes on its own morphology.

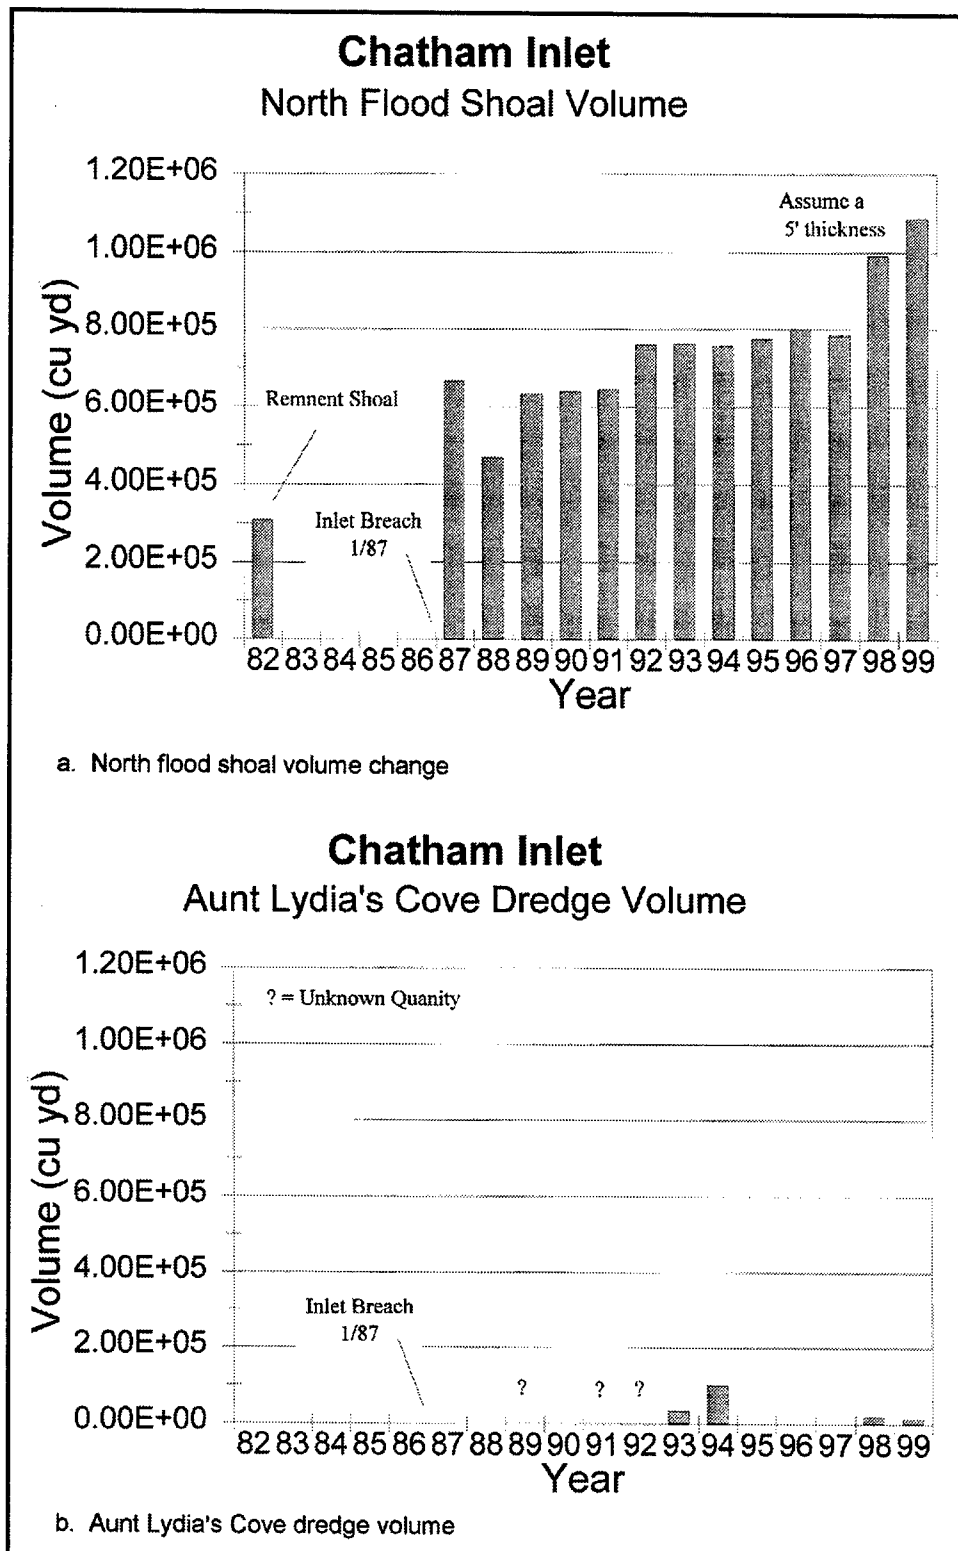
Figure 55. Comparison of north flood shoal volume change with volume of dredged material from Aunt Lydia's Cove (entrance channel and anchorage)

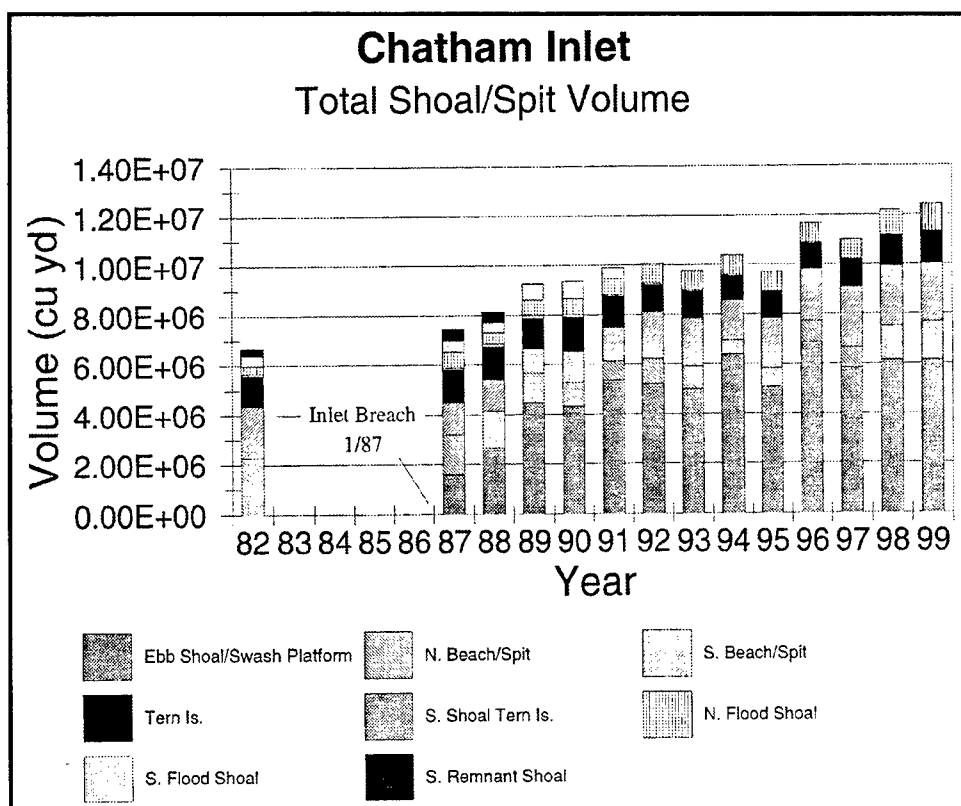
Figure 56. Total estimated volume of sediment in various morphologic units at Chatham Inlet from preinlet to 1999

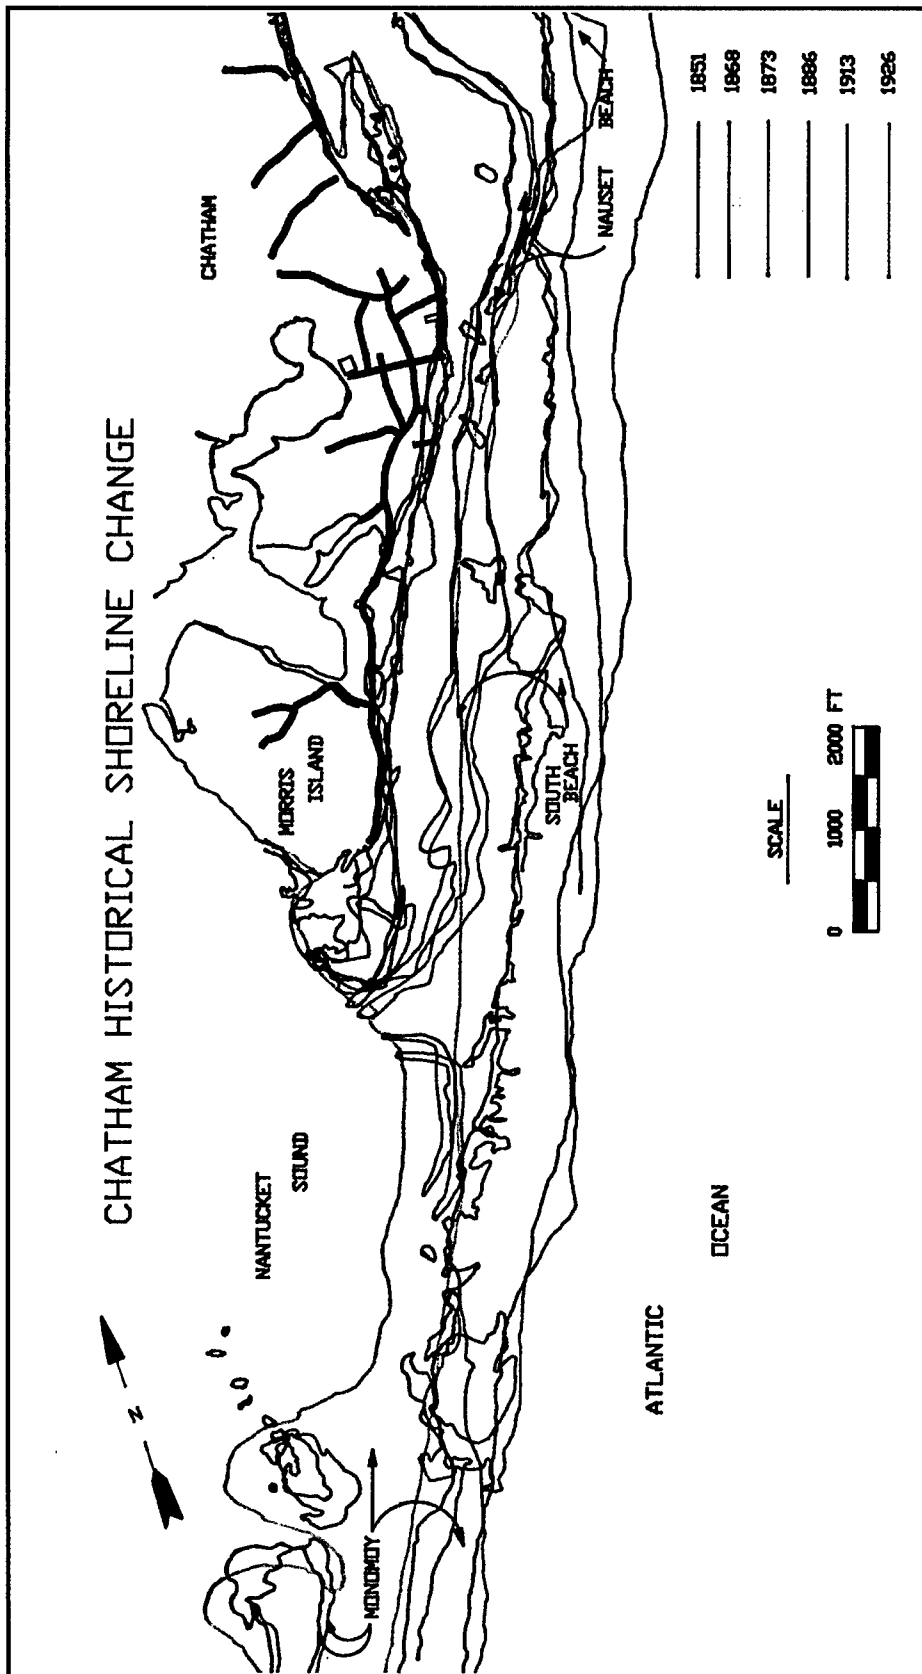
Figure 57. Historic shoreline change from last inlet breach cycle (1851-1926)
